Document 3
Asset Category – Cables
LPN

Asset Stewardship Report
2014

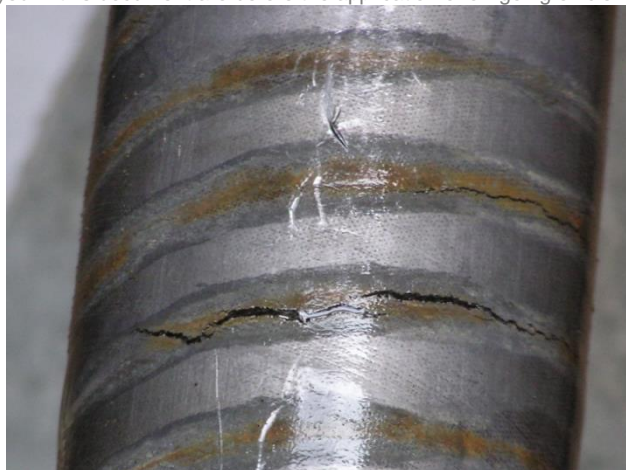
Figure 20 – Crystallised lead sheath

Lead sheath cables suffer from crystallisation of the sheath, which results in it becoming porous and discharging cable fluid into the environment. This cause has been documented in ENA ETR135. When lead crystallisation occurs, it usually does so along large sections or the whole of a circuit. As a consequence, the replacement of short section length will not alleviate this problem. Lead sheath crystallisation results in the rapid deterioration of the integrity of the cable, which cannot be managed through repeated fault repairs.

Once lead sheath crystallisation is discovered and a repair deemed not possible or unsuccessful, the replacement of a hydraulic section will be considered initially. It is, however, sometimes necessary for the whole circuit to be replaced if the condition is similar throughout the circuit length.

Should crystallised lead be discovered during a fault repair, the length of cable replaced will usually be increased to remove the length containing crystallised lead sheath.

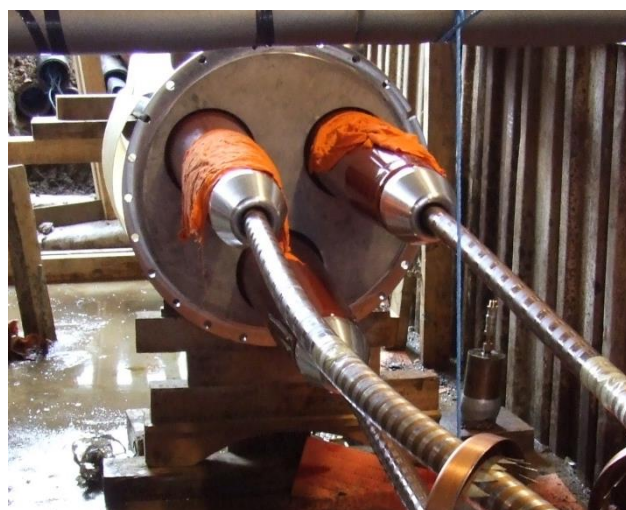
Figure 21 – Aluminium joint

Aluminium sheath cables suffer primarily from cable fluid leaks at the joint plumbs. These can often be refurbished or repaired in order to rectify leaks, although replacement of cable sections or circuits are still necessary. Tape deterioration also has an impact on the strength of the sheath that ultimately will result in fluid leakage.

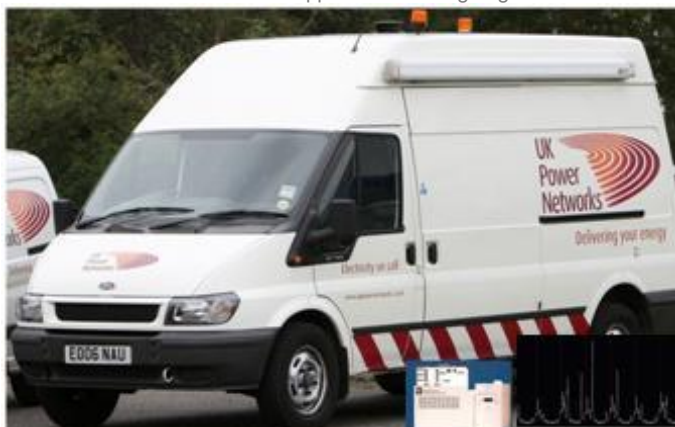
Figure 30 – PFT leak-location system

In order to offset the long-term leakage from fluid-filled cables, an innovative solution has been developed and deployed. A minute amount of Perfluorocarbon Tracer (PFT) is added to the cable fluid. PFT introduced in this way is vented to the atmosphere at the point where a leak in the cable is present – where it can be detected using highly sensitive mobile equipment. This method greatly improves performance in the detection and resolution of leaking cable incidents – reducing cost of work, outage time and environmental impact.

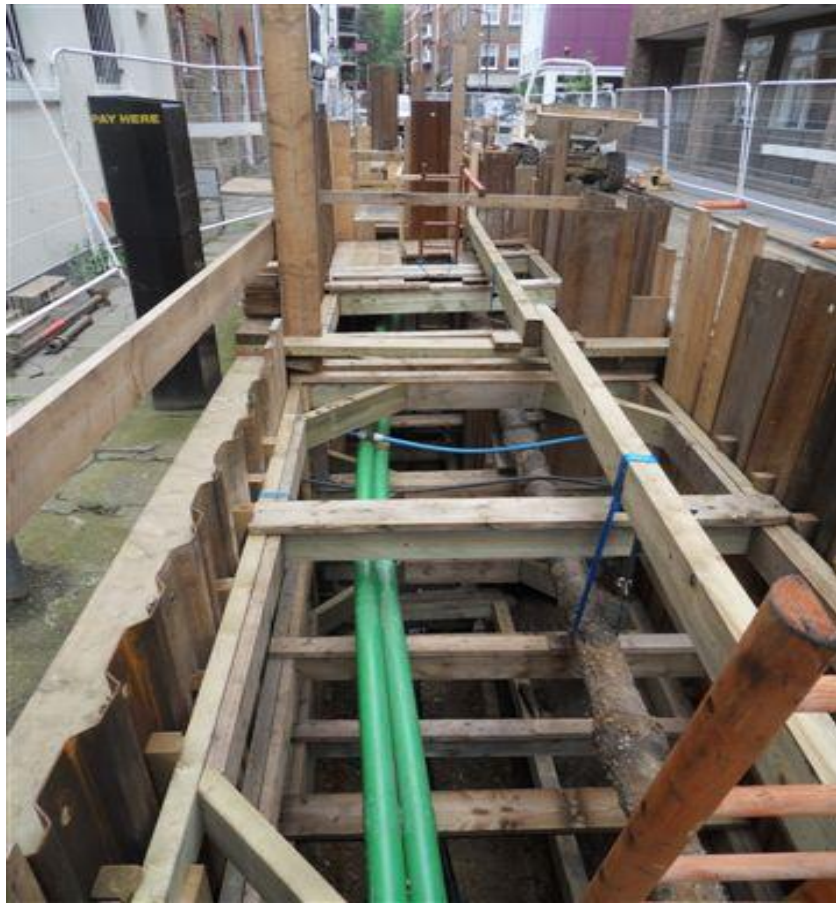
Figure 73 – Excavation required for fluid-filled cable repair at the Back Hill Fisher Street No 4 circuit

At the time of the fault, examinations were taking place at the adjacent Law Society. It was agreed with them that works would not take place during the times of the examinations due to the noise disturbance. This increased the duration and cost of the fault repair.

The lead sheath on the cable was found to be crystallised and a 10-metre section of cable required replacement.

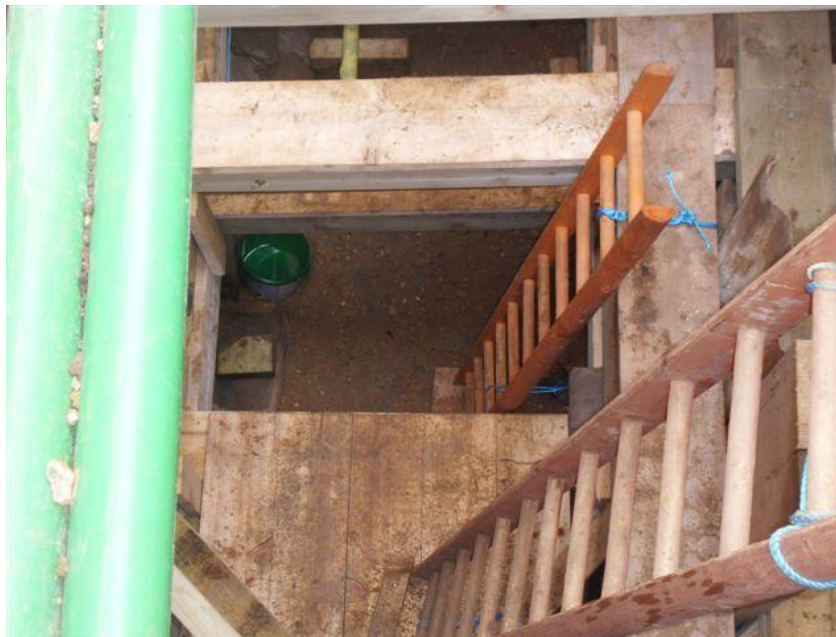
Figure 74 – The excavation was 7 metres deep (23 feet) below the ground and required a significant excavation

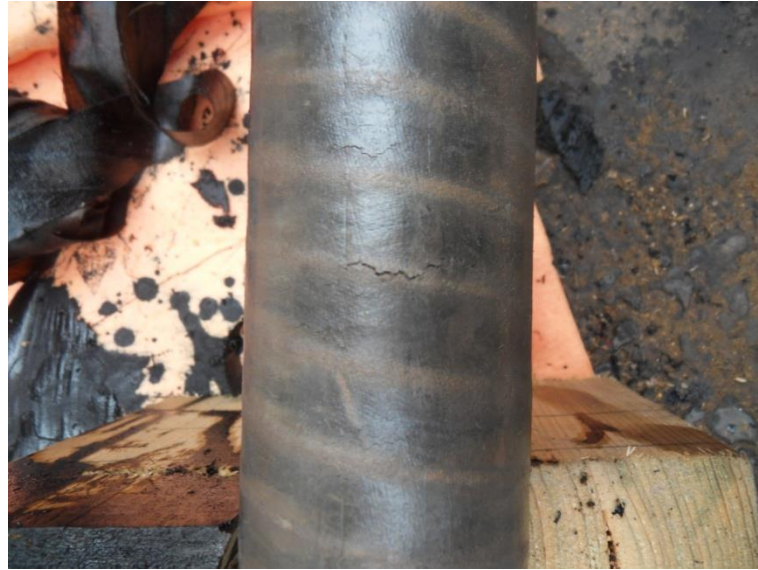
Figure 75 – The lead sheath was found to be crystallised

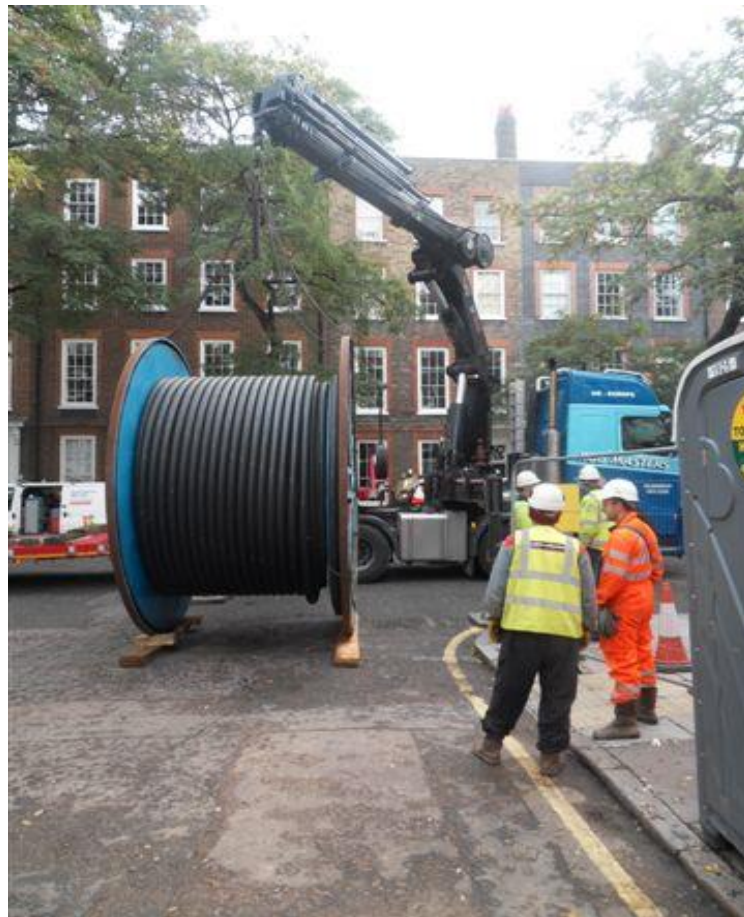
Figure 76 – The replacement fluid-filled cable is delivered to site by a specialist contractor

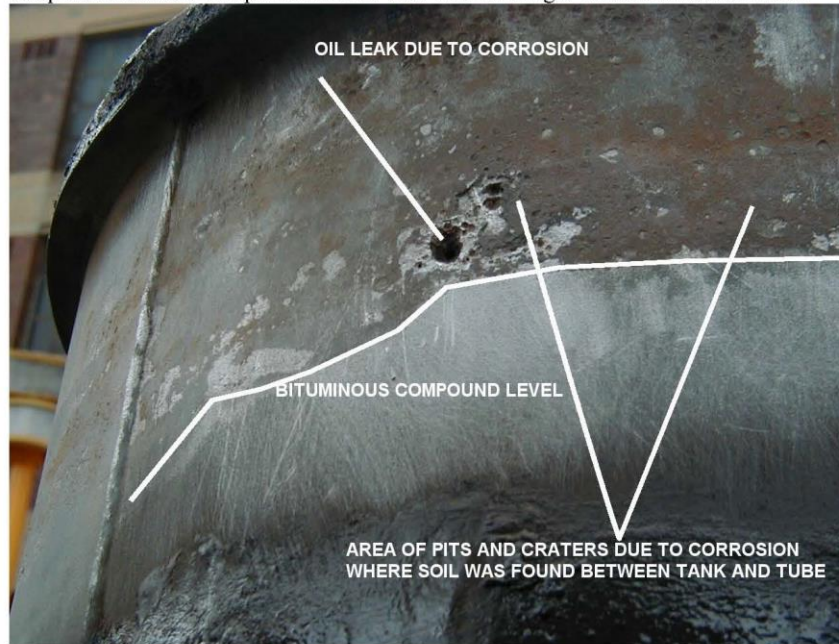
At this point the bituminous compound was lower than other points around the tank, soil had entered this area and had been a catalyst for the corrosion due to where the compound level was low.

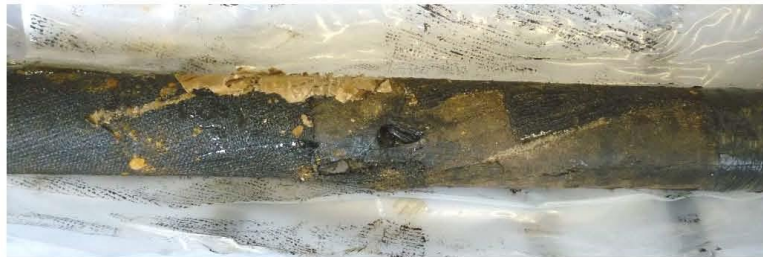
The as received condition and fault site of the sample sent to Cobham Technical Services is shown in Figs. 1 & 2.

Figure 1 As received condition

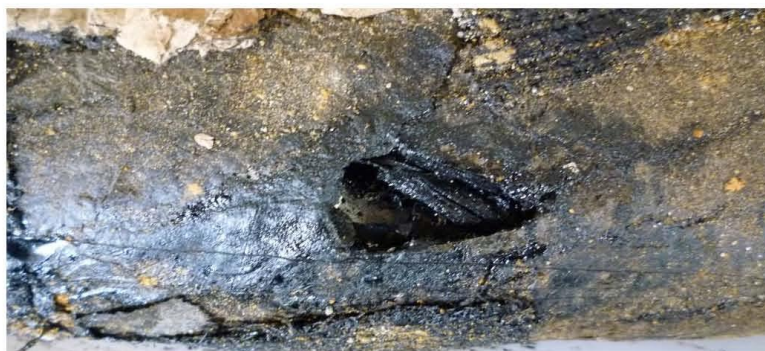
Figure 2 Fault site

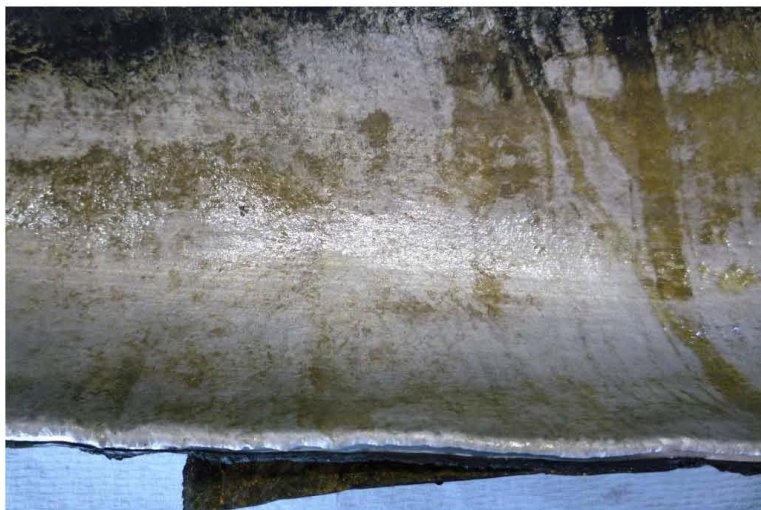
Removal of the lead sheath showed it to be in a good condition with no obvious cracks or crazing seen. The cable compound on the internal surface of the lead sheath was discoloured and starting to harden, Fig. 3.

Figure 3: Lead sheath

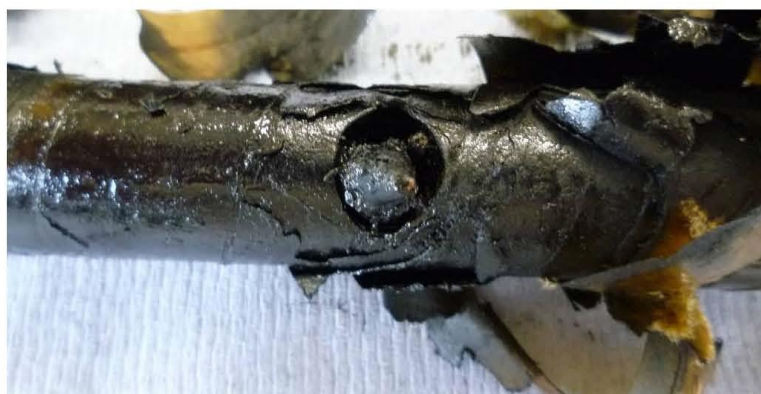
Removal of the CWFT binder showed that the fault site was on only one core, Fig. 4. The fault was at the edge of the shaped conductor.

Figure 4 Fault site

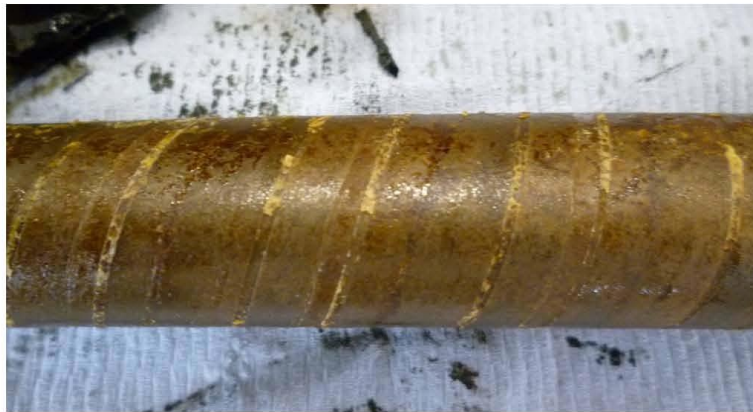
Stripdown of this core showed extensive waxing at the butt gaps of the insulation papers and hardened discoloured cable compound on the conductor strands, Figs. 5 & 6.

Figure 5 Wax at butt gaps

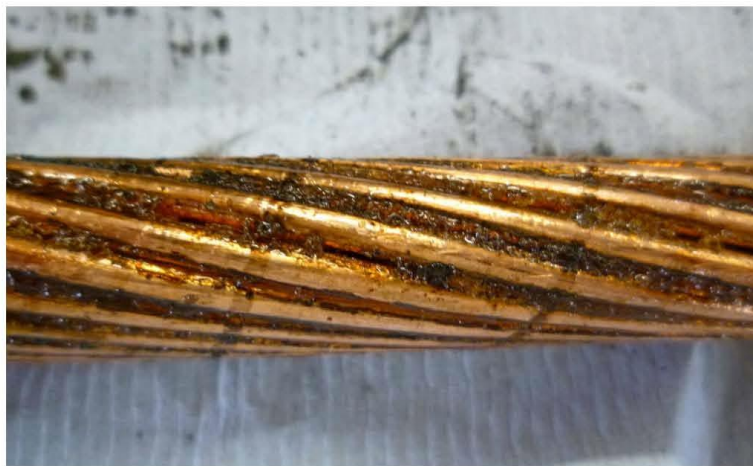
Figure 6: Hardened cable compound on conductors

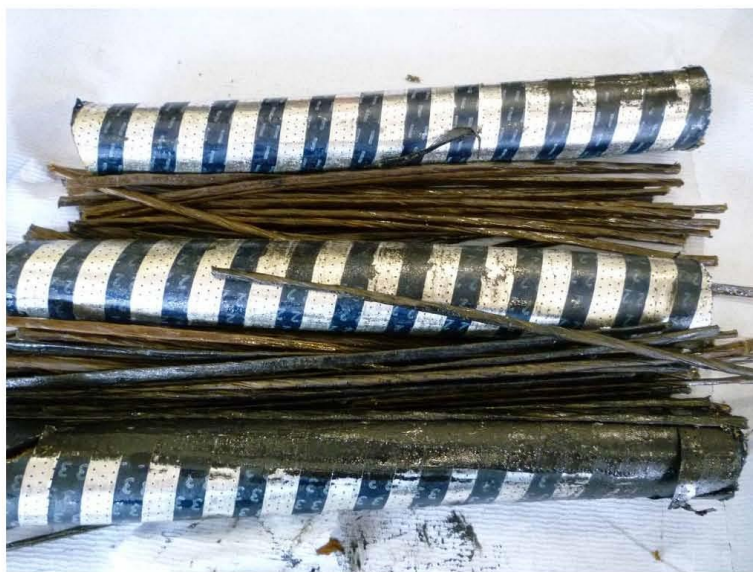
A section of cable away from the fault site was removed and stripped to assess the general condition of the cable. A core (core 2) was chosen that was seen to not have any of the carbon blown from the fault or be overly affected by the fault, Fig. 7.

Figure 7: Unfaulted cores

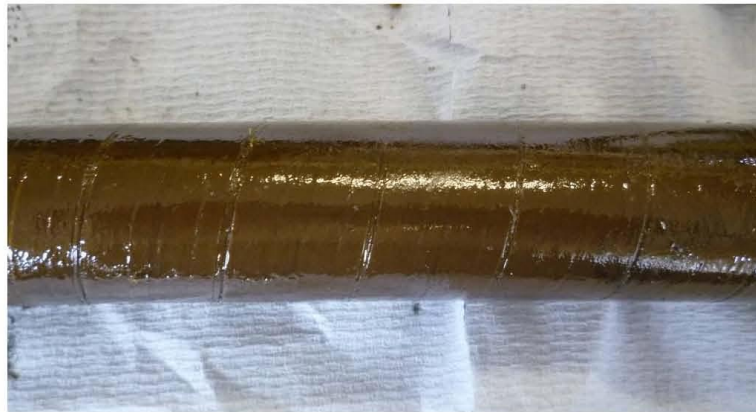
Figure 8: Oily outer insulation papers

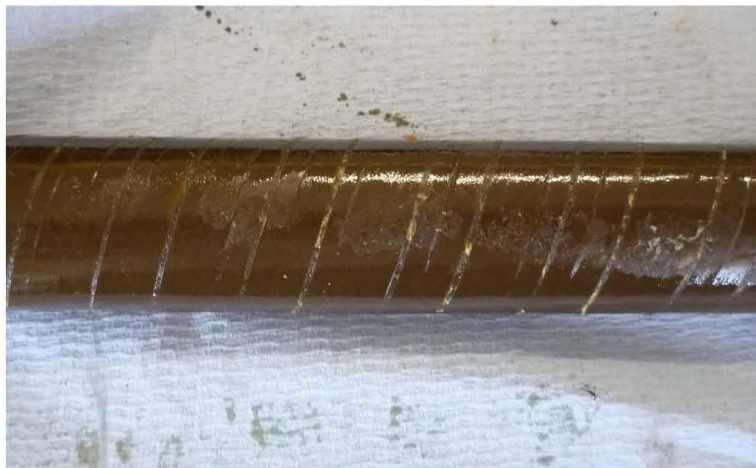
The core insulation papers were found to be oily on the outer heads of papers but minor waxing at the butt gaps was seen after half of the insulation papers had been removed, Figs. 8 & 9. Examination of the conductors revealed hardened and discoloured cable compound, evidence of partial discharge activity, at the conductor surface and between the strands, Fig. 10.

Figure 9: Minor waxing on inner insulation papers

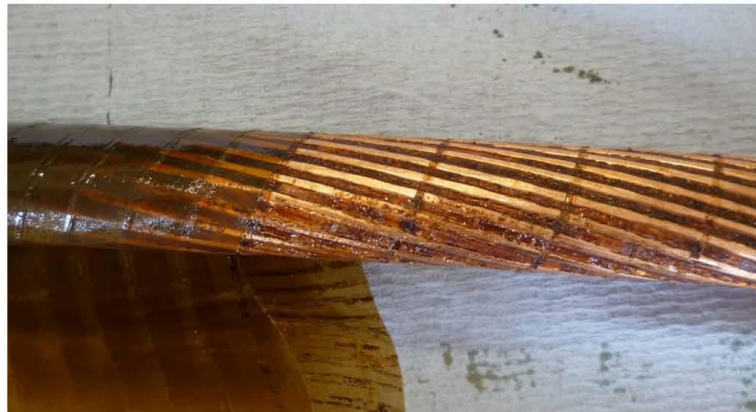
Figure 10 Hardened cable compound on strands
