Document 16
Asset Category – Cable Pits
SPN

Asset Stewardship Report
2014

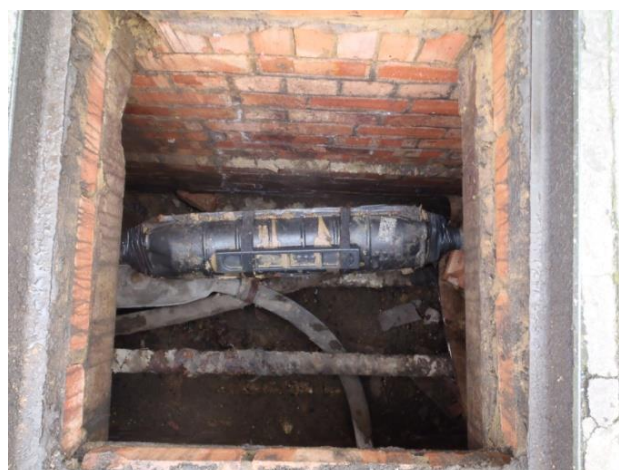
Figure 1: Example of a small cable (<1m³) pit with service joint

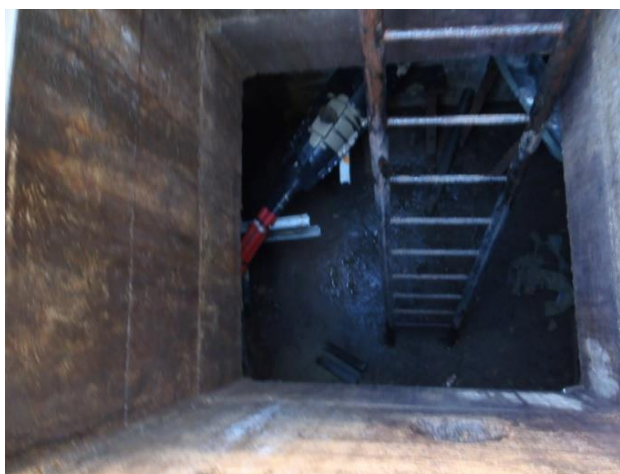
Figure 2: Example of a large cable pit with a number of cables and joints

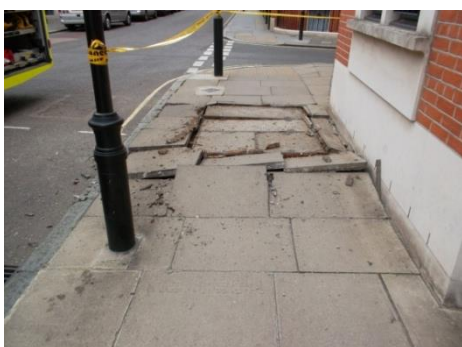
Figure 3: Footway disruption following a cable failure

The photographs below show examples of poor condition cable pits and associated defects. Figures 3 and 4 show the impact of a disruptive failure of a cable pit. This is described in more detail under section 3.5. Figures 5 and 6 give examples of other typical defects.

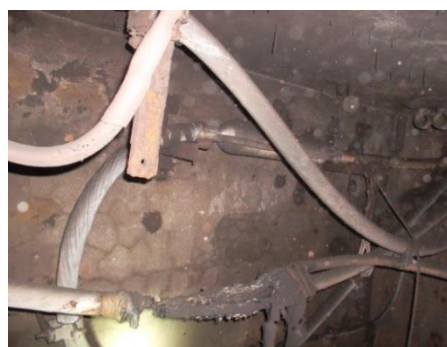
Figure 4: Status of the cable following failure

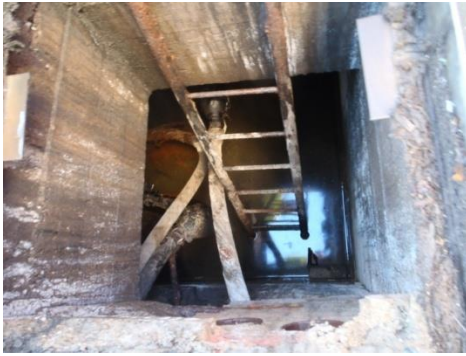
Figure 5: Poor condition ladder

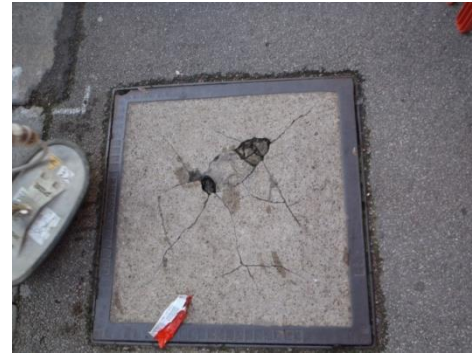
Figure 6: Poor condition cover

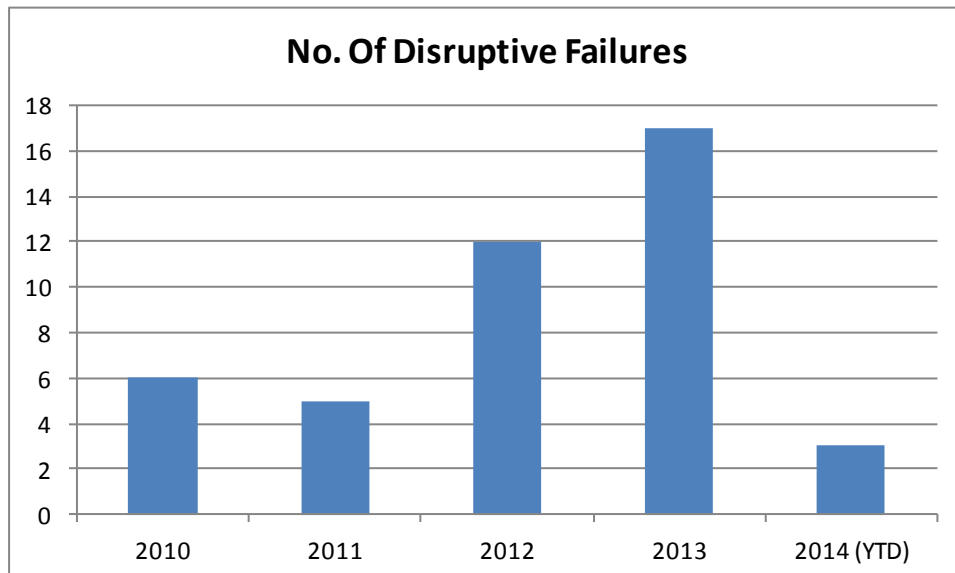
Figure 7: Cable pit disruptive failures

Figure 7 shows an increasing trend of cable pit disruptive failures in London area reported to AIRLine.

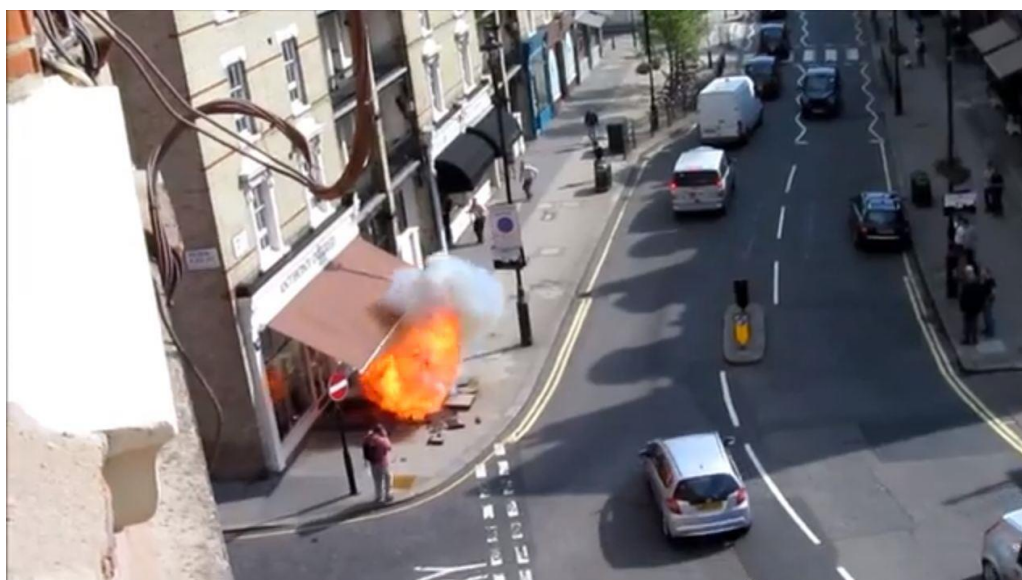
Figure 8: Pimlico disruption – April 2013

Figure 8 shows a disruptive failure of a cable pit in Pimlico in April 2013. The HSE have continued to actively monitor and support the development of UKPN's cable pit strategy and have regular meetings on progress of inspections and associated mitigation.

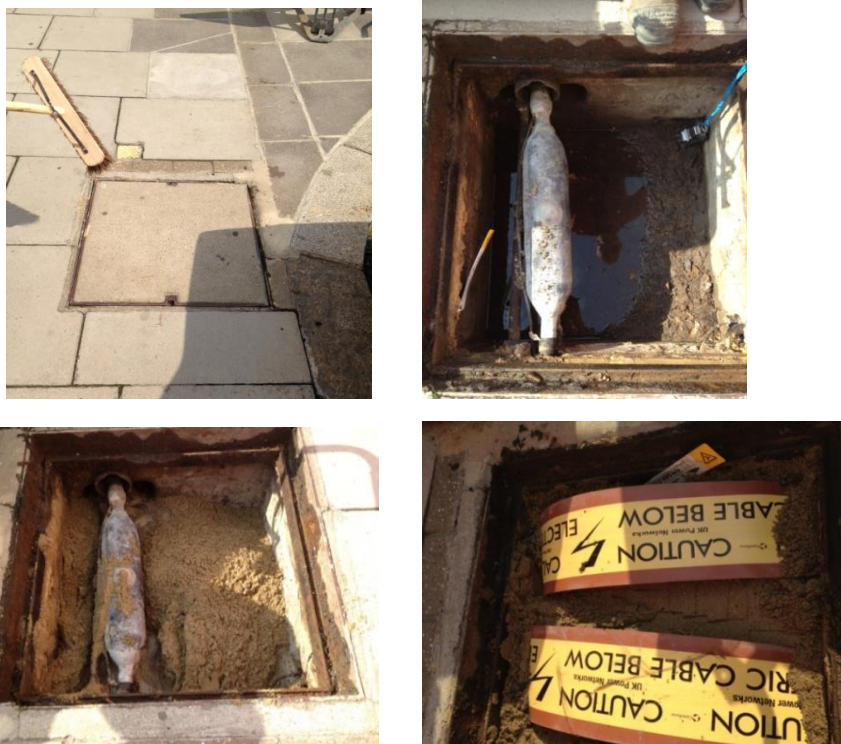
Figure 10: Example of Sand Infill Mitigations

2. Eliminate the disruptive forces caused by an arcing fault and also the potential for gas build up which would exacerbate a disruption, by filling pits with inert material such as sand. This will be applied to pits typically with a volume $< 8\text{m}^3$. This may include removal of the frame and cover, and subsequent reinstatement if the existing cover is in poor condition. For larger volume pits increasing will dilute the explosive mix and reduce the likelihood of disruptive failure. The interval between inspections for these pits will also be increased.

A number of mitigations are proposed including deployment of a vented cover, infilling of pits, replacement of defective covers, correction of defects and provision of fall restraint systems as well as the development of new policies and procedures. Further assessment and design is considered necessary due to the limitations associated with the proposed covers and the uncertainty around the forces that occur during a disruptive event.

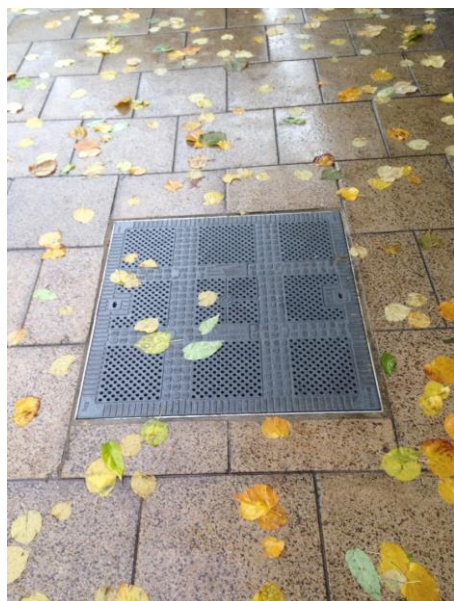
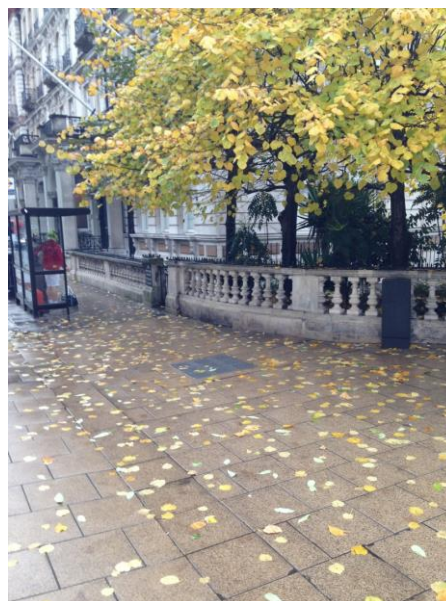
Figure 11: Example of FFP10 installation – Grosvenor Place

UKPN has adopted the SSC 'S' Panel cover as the basis of design of a new cover, the SSC (Footway Fault Protection) FFP10 cover. It is a vented composite fibreglass cover which measures 860 x 860mm, and has over 1000 10mm diameter vents over its surface (providing a vent area of ~12%). It has been developed by UKPN in conjunction with SSC,

following the principles of the 'S' Panel developed with Consolidated Edison. The 'S' Panel has been tested in arc event simulation tests, based on a chamber exposed to a gas explosion, and supports the use of vents and a locking restraint system to reduce the possibility of ejection of the cover. These covers are locked which will prevent uplift, and will also be tethered in the event of a lock failure. Figures 11 and 12 show examples of where this has been installed.

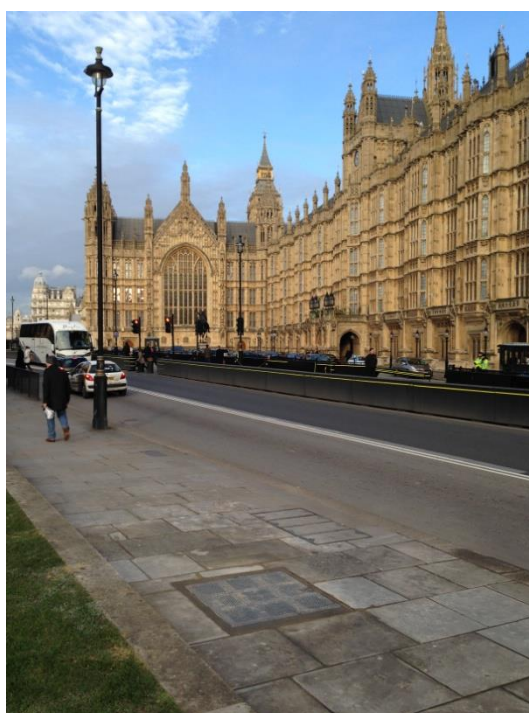
Figure 12: Example of FFP10 installation – Palace of Westminster

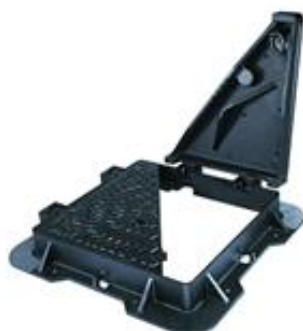
Figure 13: St Gobain Opt-Emax cover

The mitigation proposals for cover replacement assessed two covers as potentially appropriate: the St Gobain Opt-Emax cover (Figure 13) within trafficked areas and the Structural Science Composites (SSC) S Panel (Figure 14):

- The Saint Gobain Opt-Emax cover is a hinged ductile iron cover, which has a range of 'off the shelf' sizes ranging from 600 x 450mm clear opening to 1800 x 750mm clear opening sizes. The hinges are integral to the cover and lock into the frame.

It should be noted that the St-Gobain covers have not been designed or tested for any specific disruptive forces applied on the underneath of the covers. Further investigative testing and design would be necessary. UKPN therefore favour the SSC 'S Panel' cover and have proposed to adopt this cover as the mitigation recommendation to reduce the severity of an injury associated with a cover being ejected.

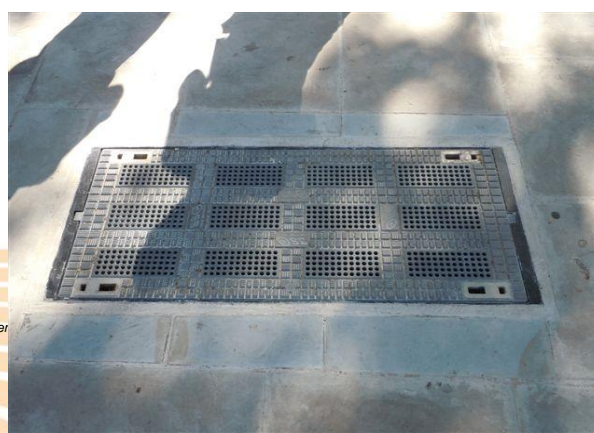
Figure 14: Structural Science Composites (SSC) 'S' Panel

- The SSC 'S Panel' cover is a vented composite fibreglass cover. It measures 605 x 1365 mm and has 750 12mm diameter vents over its surface (providing a vent area of ~10%). It has been developed with Consolidated Edison and is the only product considered that has undertaken load tests on the underside and arc event simulation tests. The testing is based on their use within a chamber exposed to igniting gas and supports the use of vents and a locking restraint system to reduce the possibility of ejection of the cover. UKPN are developing a smaller 'standard size' 800x800 cover

that will be fitted to the majority of cable pits where a cover requires changing either due to damage or mitigation.

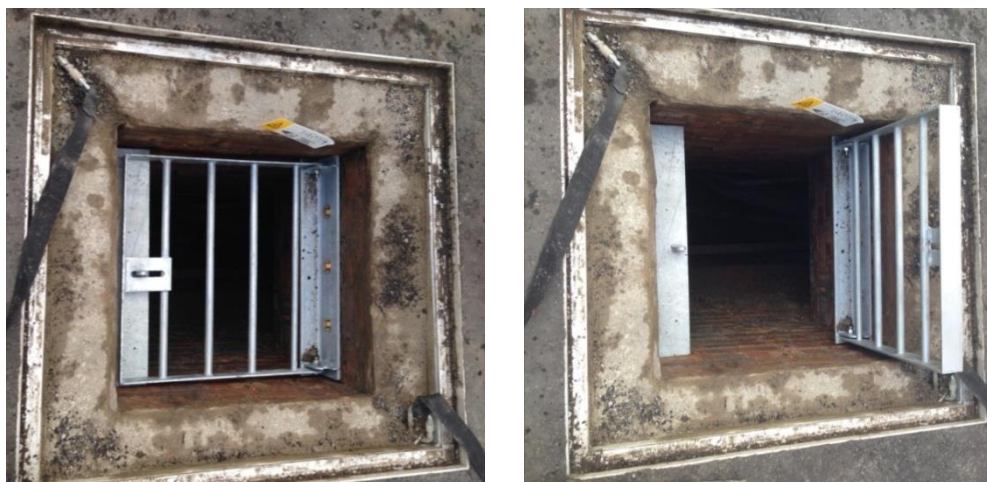
Figure 15: Example of fall arrest installation

UKPN are also researching the use of a fall arrest system (Figure 15) for deep pits to ensure that if the covers are dislodged no person accidentally falls in to the pit. The mitigation will consist of an open grid floor just below the cover and applied to pits with ESQCR rating of high or very high, and to those pits with a depth $\geq 3\text{m}$.

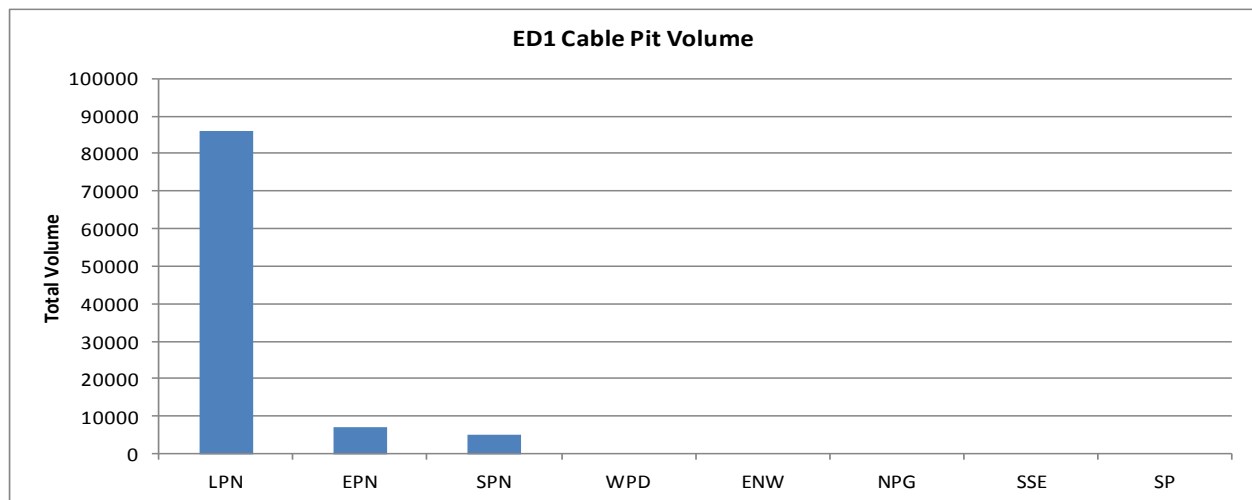
Figure 21: Cable Pit Volumes/DNO

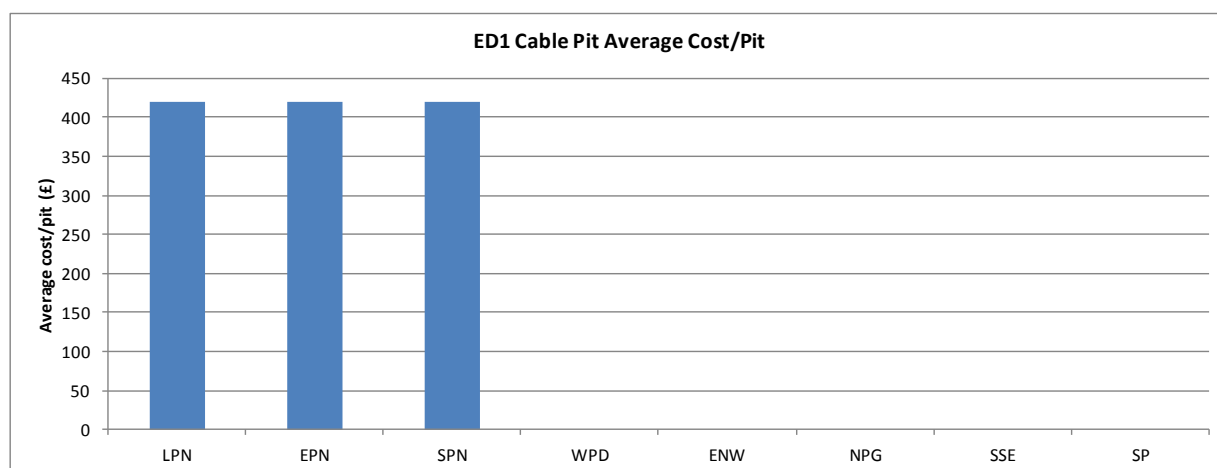
Figure 22: Cable Pit Average Cost/Pit
